ATLANTIC DIVISION,
NAVAL FACILITIES ENGINEERING COMMAND

ACCIDENT ABSTRACT

Accident Type: Crane Accident
Injury: N/A
Type of work: Barge Mounted Crane
Equipment: 150 Ton Crane on Barge

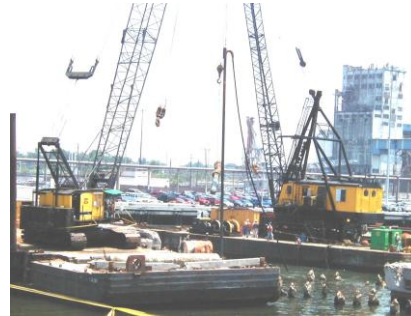
A 150-ton crane was working on the north side of Pier22. The crane operator was in the process moving to a location where the crane could pull the “spuds” on the barge and while moving forward the crane started to slide. There was no load on the crane. Crane operator turned the crane cab around to see what was happening and the crane slide off the barge into the water. The operator jumped from the cab onto the barge and watched as the crane fell off the barge.

- 1) Crane not tethered to the barge.

- 1) Snow and ice not removed from the barge deck before going to work
- 2) Crane driver not following the revised crane plan for land mounted cranes on barges.

- 1) Crane not set-up in accordance with the modified crane plan.
- 2) No record of the ROICC office having received the new crane plan.
- 3) Crane was in violation of EM-385 section 16 F.06 by not having a means of a slack tie down system to tether machines travel.
- 4) Superintendent not being responsible for safety on the jobsite.
- 5) No activity hazard analysis was done before starting this phase of the work.
- 6) Start-up inspection checklist not answered correctly as to crane being tethered.
- 7) Operator should have stopped the entire operation because of unsafe conditions.
